# Evaluation of Comsol as a tool for pinpointing moisture entering locations from inside surface moisture

A.W.M. (Jos) van Schijndel, Eindhoven University of Technology  
Eindhoven, Netherlands

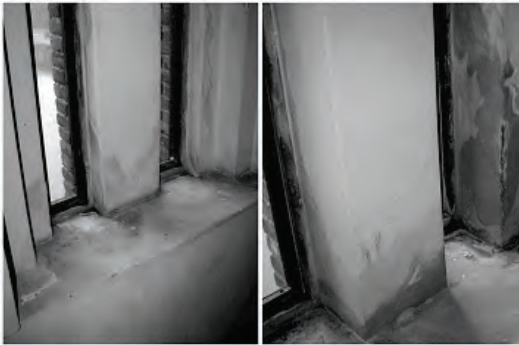
**Figure 2.** Observed moisture damage in the tower of the building: moist spots and efflorescence

The damage that occurs in the tower were systematically inspected to enable a thorough assessment of the possible causes of the moisture problems by Briggen et al. (2009). The damage on the inside of the tower, and where possible also on the outside, is systematically inspected. The location and type of each moisture problem are documented in a table, illustrated with a picture of the damage. The moisture problems that manifest themselves in the tower of the Hunting Lodge can be divided in the following categories: efflorescence, cracking, soiling, moist spots, mechanical damage and biological growth. A few pictures of the moisture damage that occurs in the tower are shown in figure 2 (Briggen et al. (2009)).

Regarding the location of the damage it can be concluded from the inspection that most damage occurs on the interior surface of the south-west facade of the tower. Since the prevailing wind direction in the Netherlands is south-west, which means that the south-west facade of the tower is subjected to wind-driven rain the most, there appears to be a connection between the rain load of the facade and the damage on the inside. There are no clear differences between the damage on lower or higher floors or between the damage on the middle and on the sides of the facade. Most damage occurs near openings in the facade and on the interior surface of the facade below balconies.

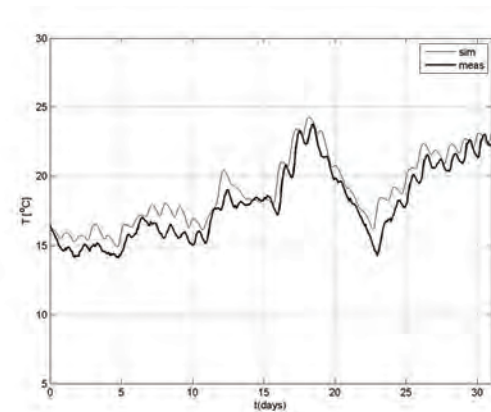
**Figure 8.** The measured and simulated inside surface temperature.

Figure 8 shows that the simulated inside surface temperature is already quite close to the measured one.

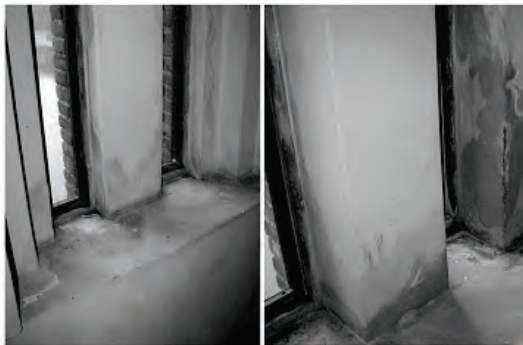
**Figure 10.** Observed moisture spots at the inner surface near the windows

In this Section we try to reproduce the following observed moisture spots (see figure 10).

There is no match between the simulated profile at the inner surface of figure 13 with the observed profile of figure 10. Therefore it is concluded that the location of figure 12 is not a possible candidate that causes the observed moisture spots. In the Appendix an overview is provided of nine more moisture profiles caused by corresponding possible wet locations. From these results, the best candidate for the moisture leakage location seems to be at the bottom of the window.
